# PADIHAM ZONE 2 AUDIT March – May 2026

## Introduction

Between 24 April and 7 May 2026, an external audit was carried out on properties and the surrounding neighbourhood within Zone 2 of the Padiham Selective Licensing area. Prior to the external inspections, a desktop audit was completed to review the status of all properties in the area and to assess compliance with licence conditions for those properties already licensed.

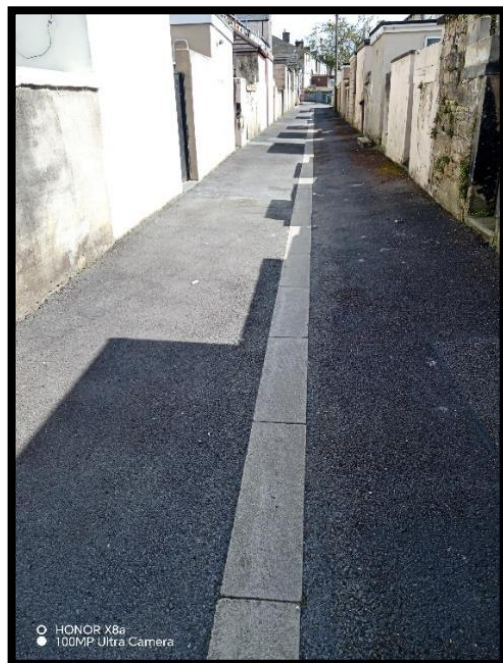
There were several examples of well-maintained back streets within the audit area where no issues were identified. Areas protected by alley gates appeared to be well respected and maintained.

*Back street of Canning Street and Stockbridge Road showing clear and well-maintained areas.*

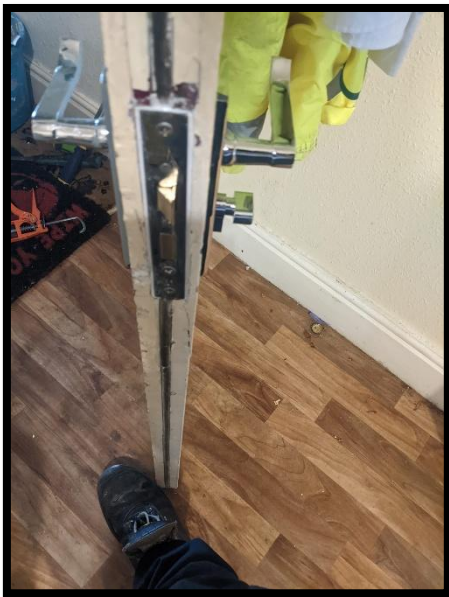
*Thumbscrew locks to flat doors*

- Three properties owned by the same landlord had each been converted into three single-person flats. To improve fire safety compliance, the landlord agreed to:
  - Install thumb-turn locks to flat entrance doors to allow safe exit without the need for keys.
  - Replace four windows with fire escape-compliant windows.

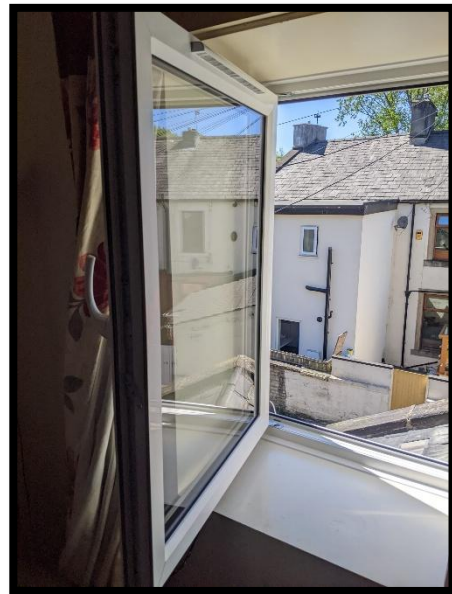
*Installation of new fire escape window*

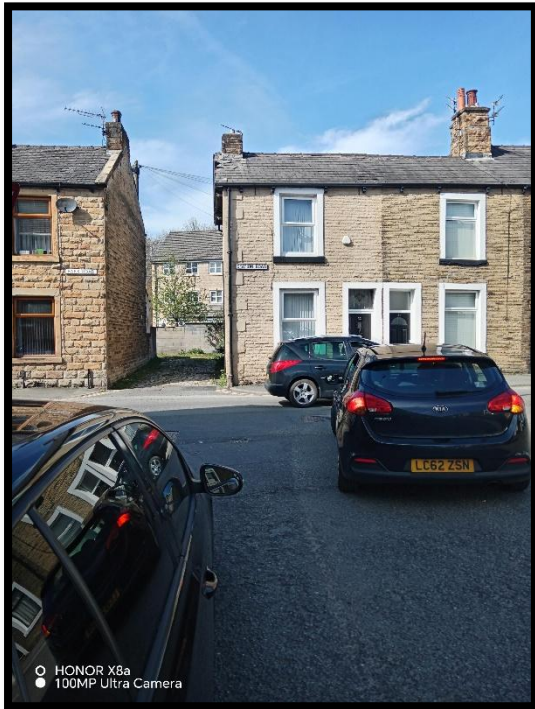
*Before – dangerous slipped roof tiles*

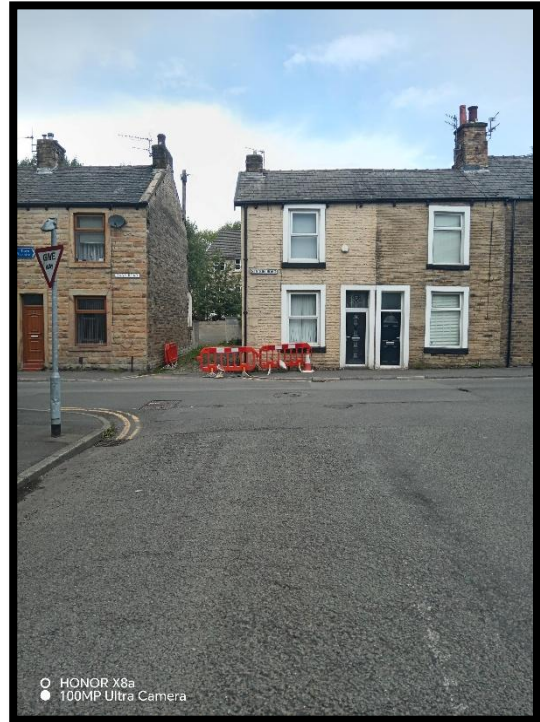
*After – Roof works completed*

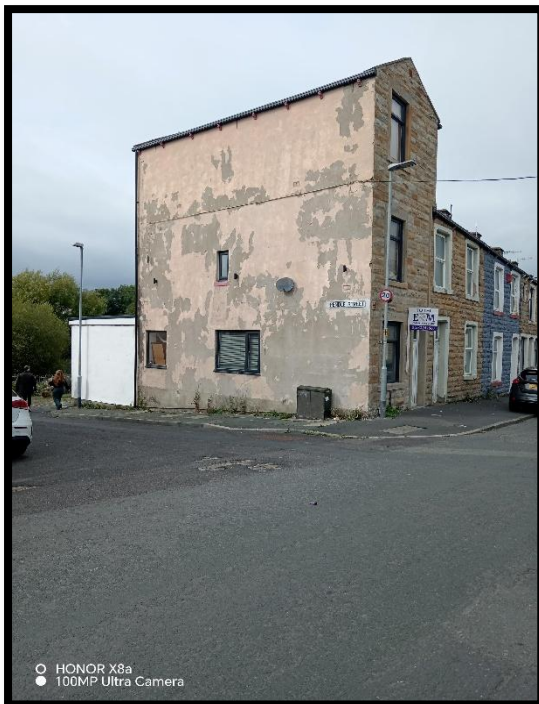
*Before – Side elevation of property*

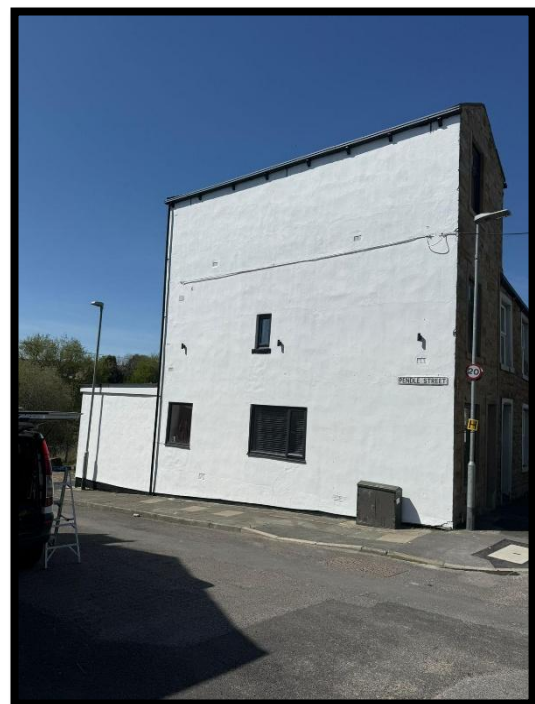
*After – Side elevation repainted.*

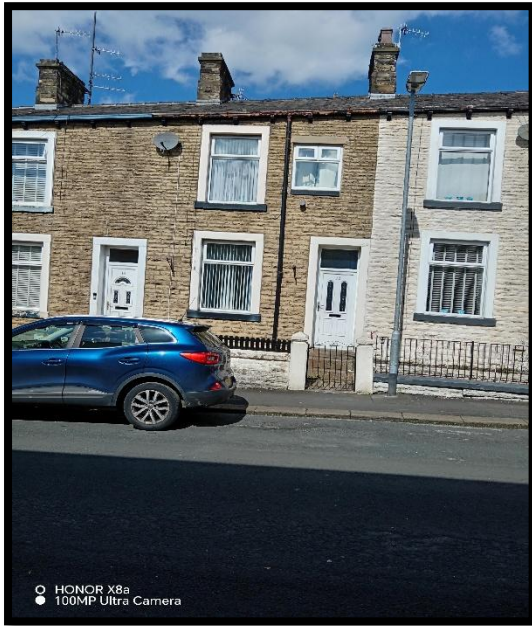
*Before – Rotton front gutter*

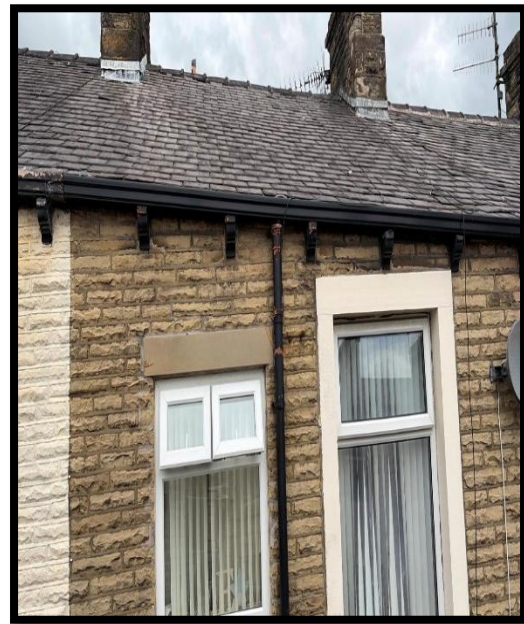
*After – New Gutter installed*
