# Pine St Audit

6th November 2023

## 1 Introduction

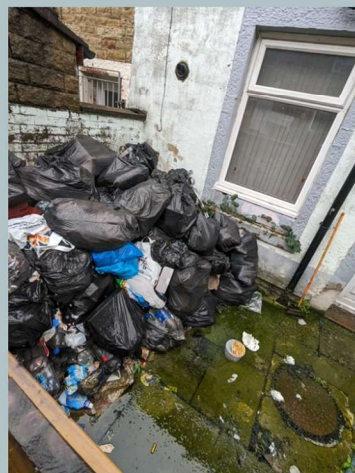
On initial review of the properties we found that 7 were vacant, 2 of these are now occupied, 3 are being dealt with by our Empty Homes Team and 2 are awaiting new tenants to occupy them. 2 of these properties had severe Dirty Back Yards which are now clear as shown in the images below.

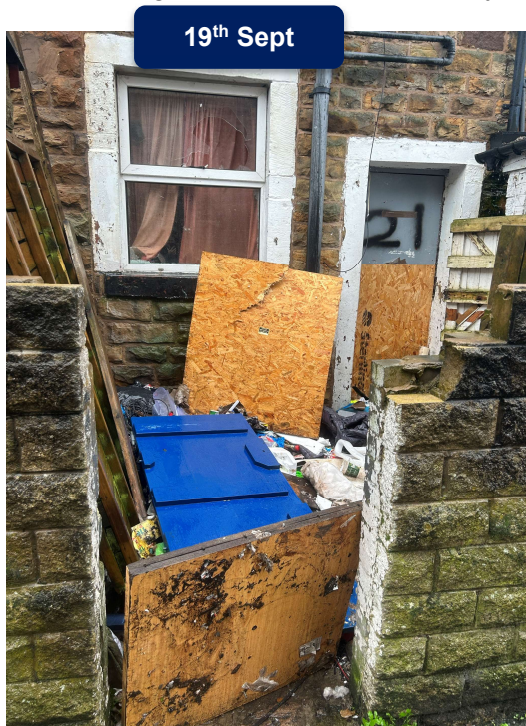
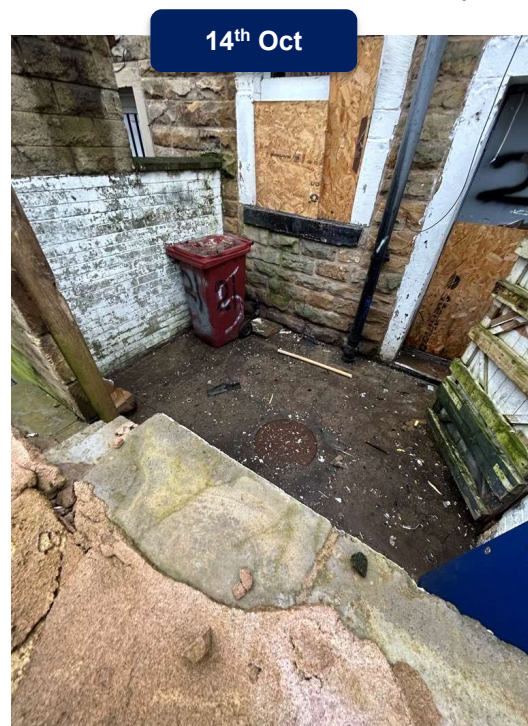
The below property is one of the vacant properties on Pine St. With the property being unoccupied it is not licensable but as you can see the waste building up in the yard could be one of the factors causing the rodent issue and was attracting more waste to be dumped due to the lack of gate. We contacted the owner following the initial audit and he cleared the yard by the deadline given. There was also a large fence panel secured to the wall covering the access to the yard. Although this is not a secure gate and not the best visually, it is not causing a fire risk as the property is vacant and no one has access to the yard.

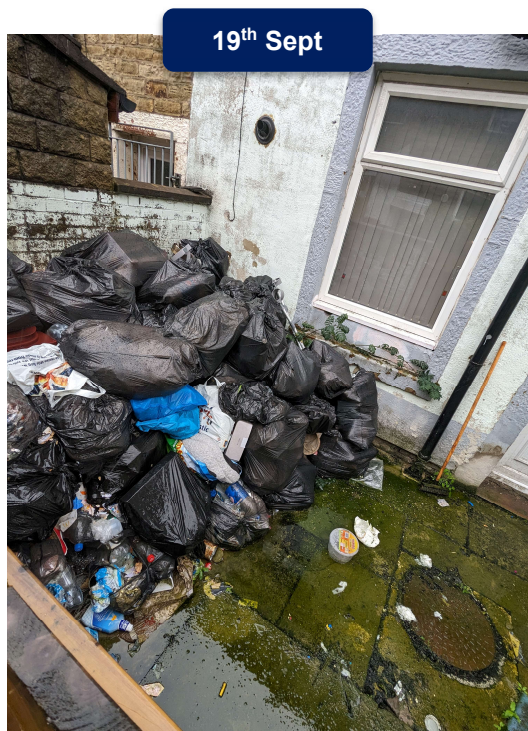
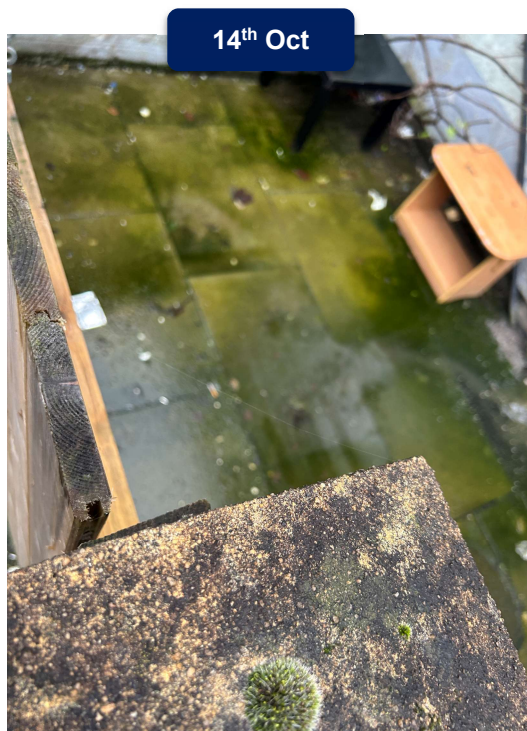
Below you can see another severe dirty back yard. Again, the Managing Agent was contacted following our initial audit date and confirmed the waste was left following a tenant vacating. The waste was removed within a few days followed by an email confirming it had been completed.

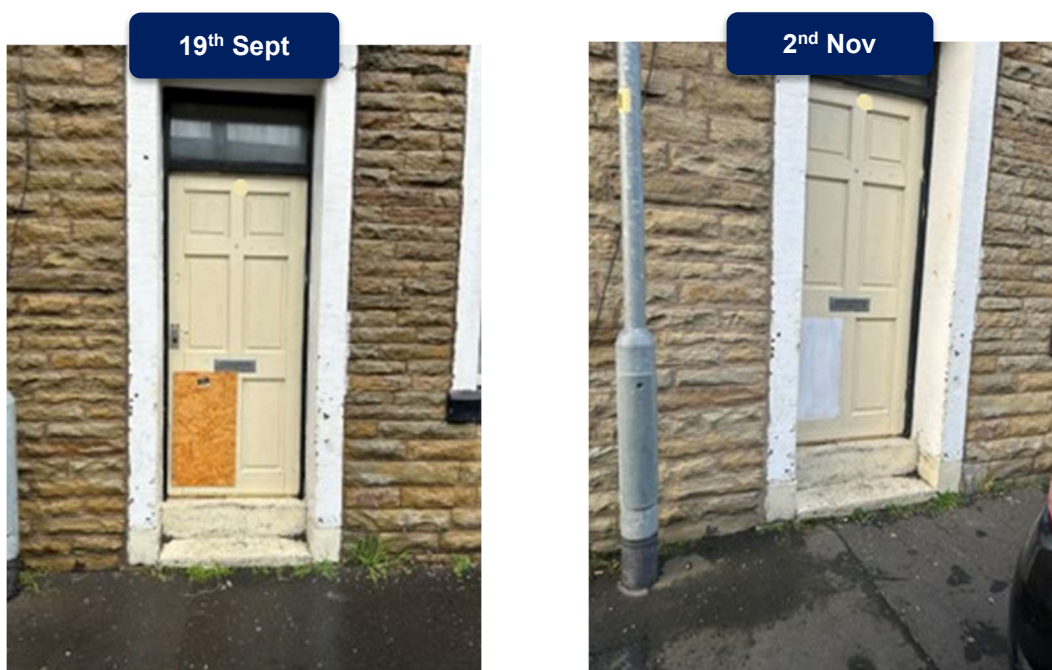
The image below shows a door which had a wooden board over a panel, it had been this way for quite some time. We asked the responsible party to replace the door, but they confirmed the door was still in working order and will be fixing the broken panel. The repair was completed by the final follow-up date and the door will be painted shortly.

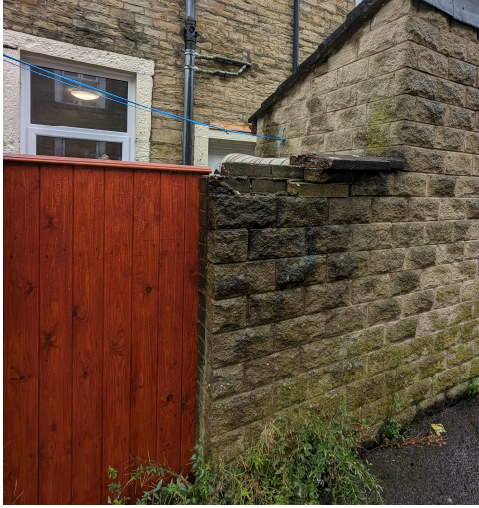
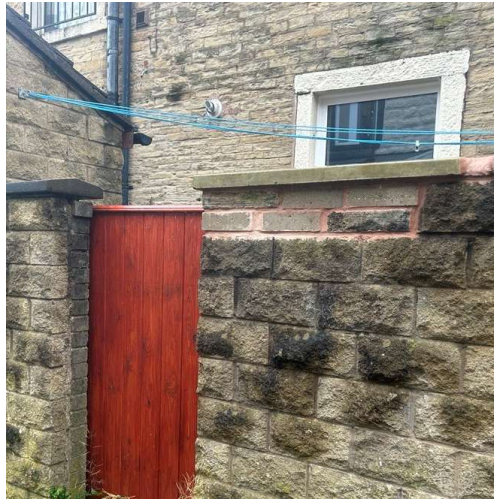
A common disrepair was also damaged coping stones on yard walls, with the stones either being loose or missing. As you can see from the image below, this wall had a large coping stone missing and damage to the bricks underneath. This over time could cause further issues to the yard wall such as bricks falling and the wall becoming unstable. We contacted the landlord/managing agent advising of this and the repair was completed by the final follow-up date.
