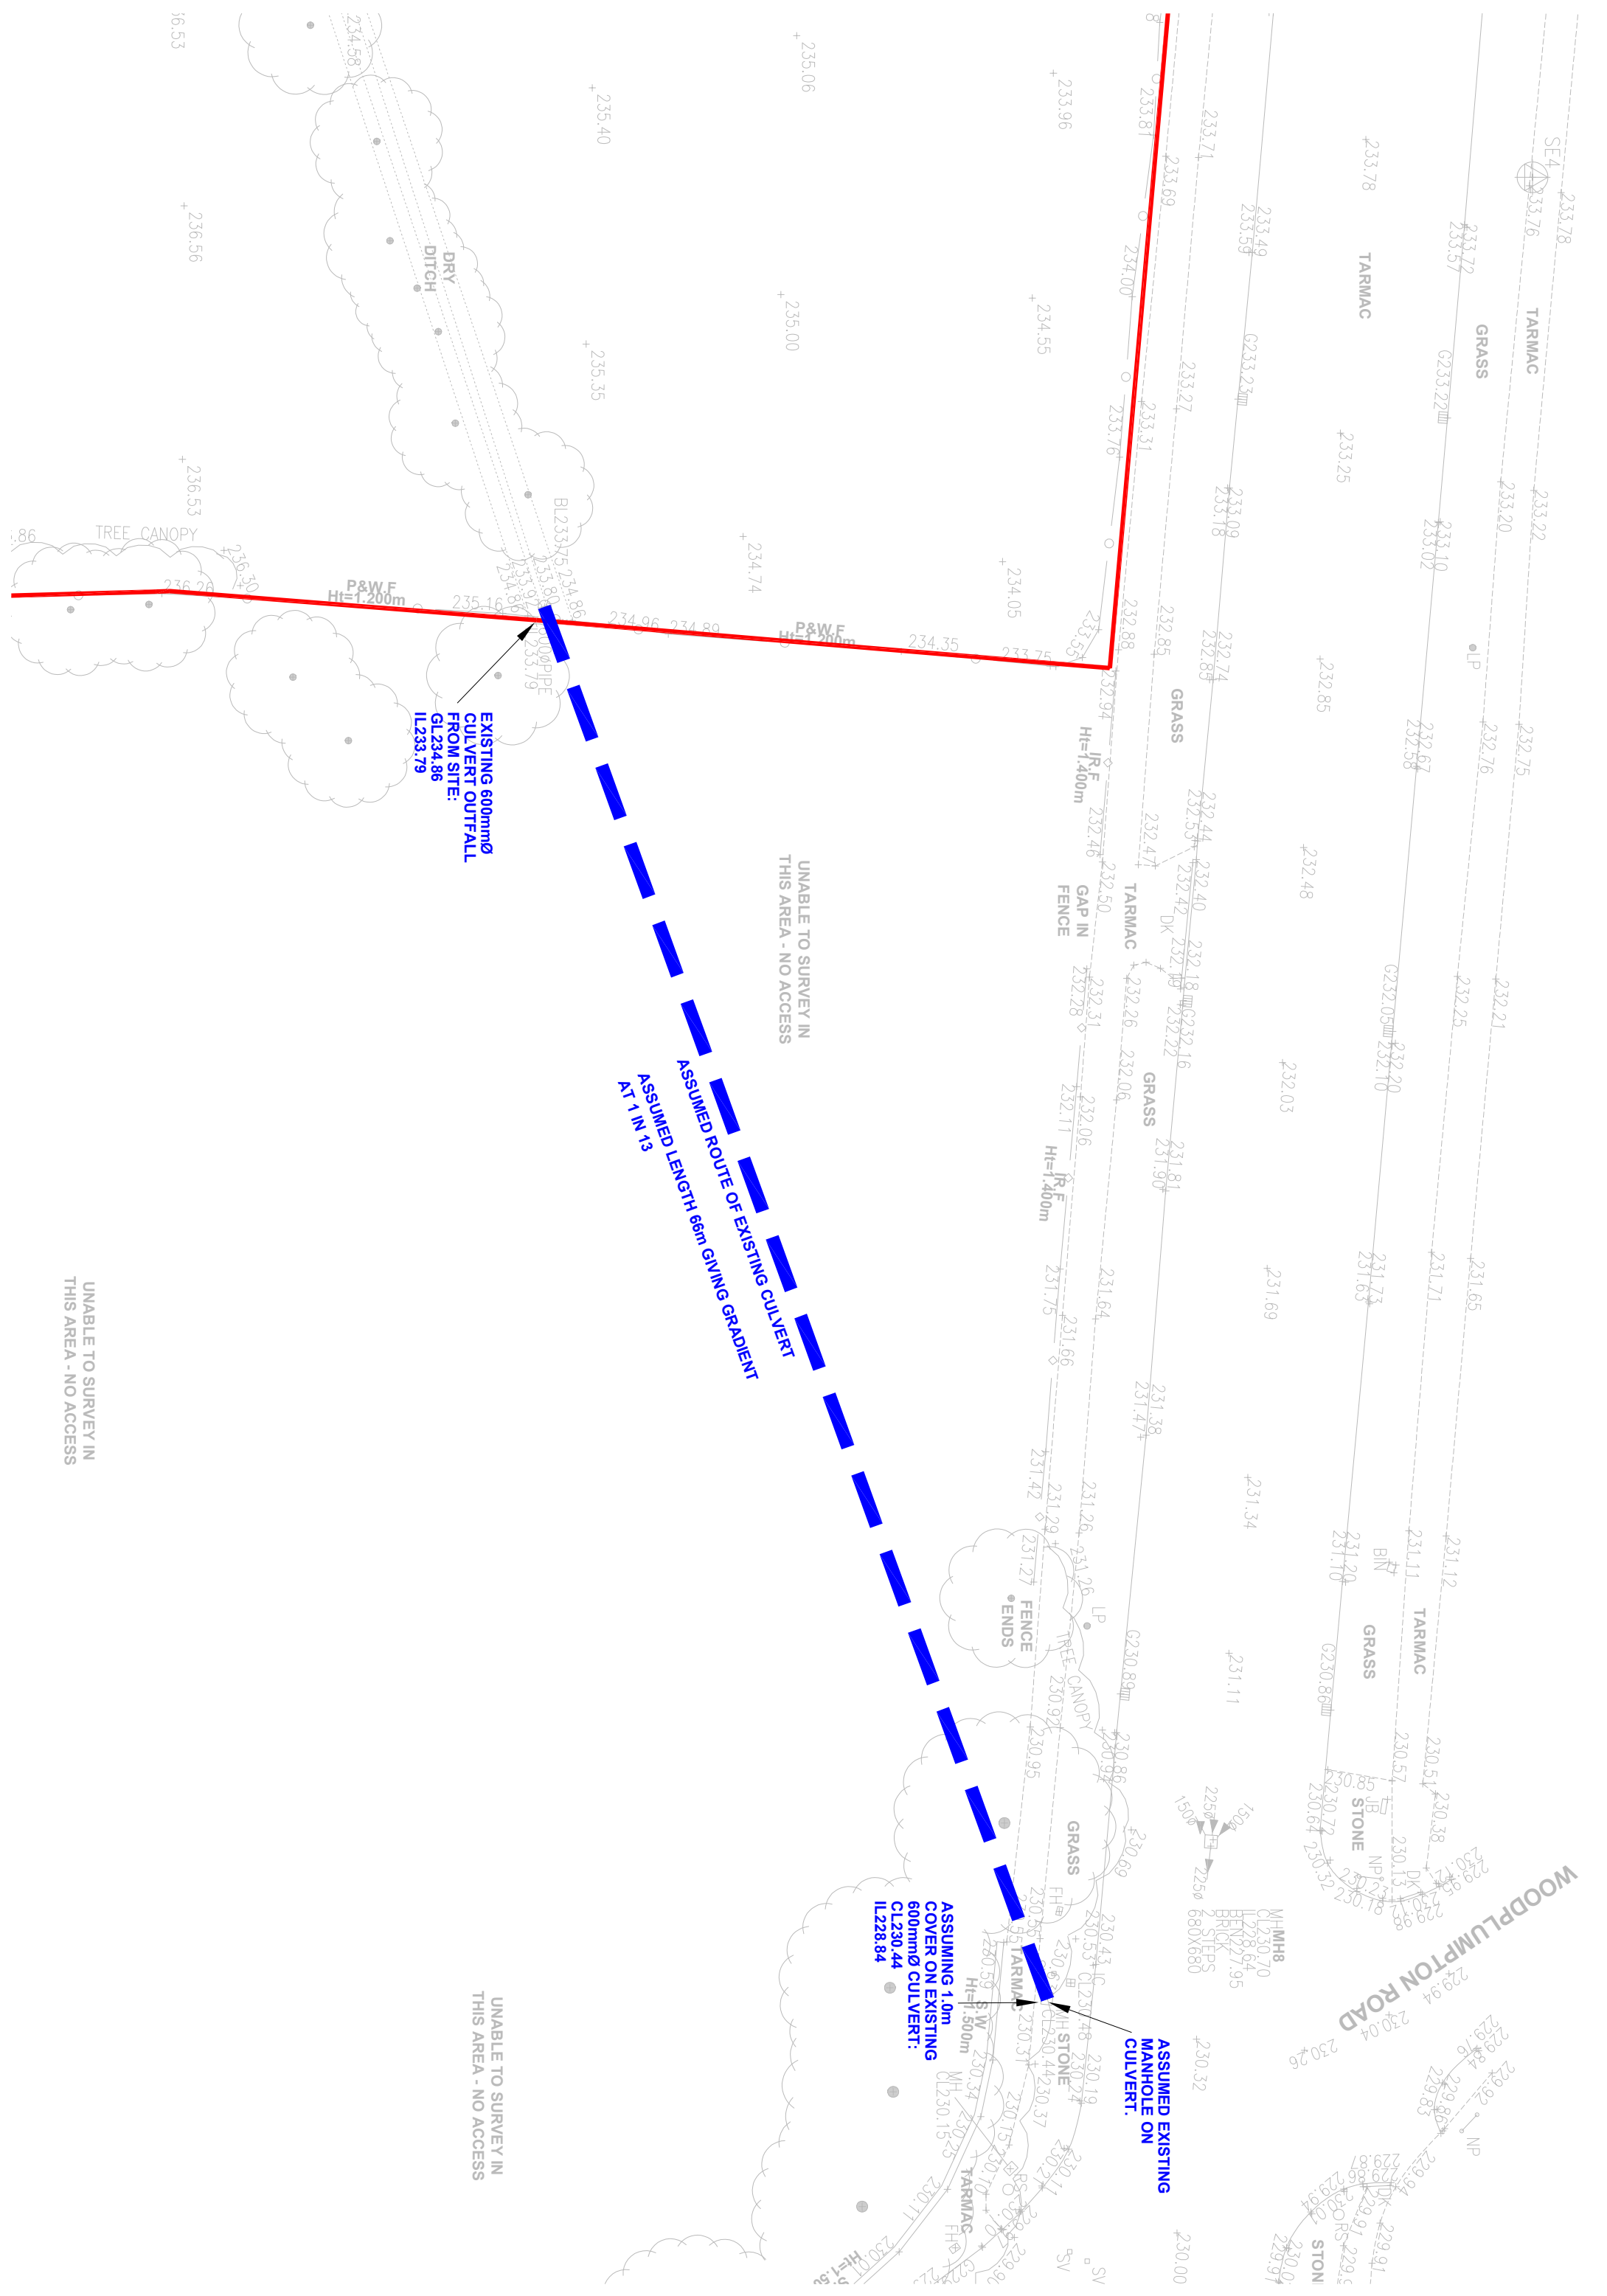
ASSUMED ROUTE OF EXISTING CULVERT
ASSUMED LENGTH 66m GIVING GRADIENT
AT 1 IN 1.3

EXISTING 600mmØ
CULVERT OUTFALL
FROM SITE:
GL234.86
IL233.79

ASSUMED EXISTING
MANHOLE ON
CULVERT.

ASSUMING 1.0m
COVER ON EXISTING
600mmØ CULVERT:
CL230.44
IL228.84
